GEO/PLAN ASSOCIATES

Re: Evaluation of Proposed Emergency Shore Protection and Proposed
Extension of Shore Protection Measures to East and West of the Property.
Schifter Residence
35 Pocha Road Extension
Edgartown, MA

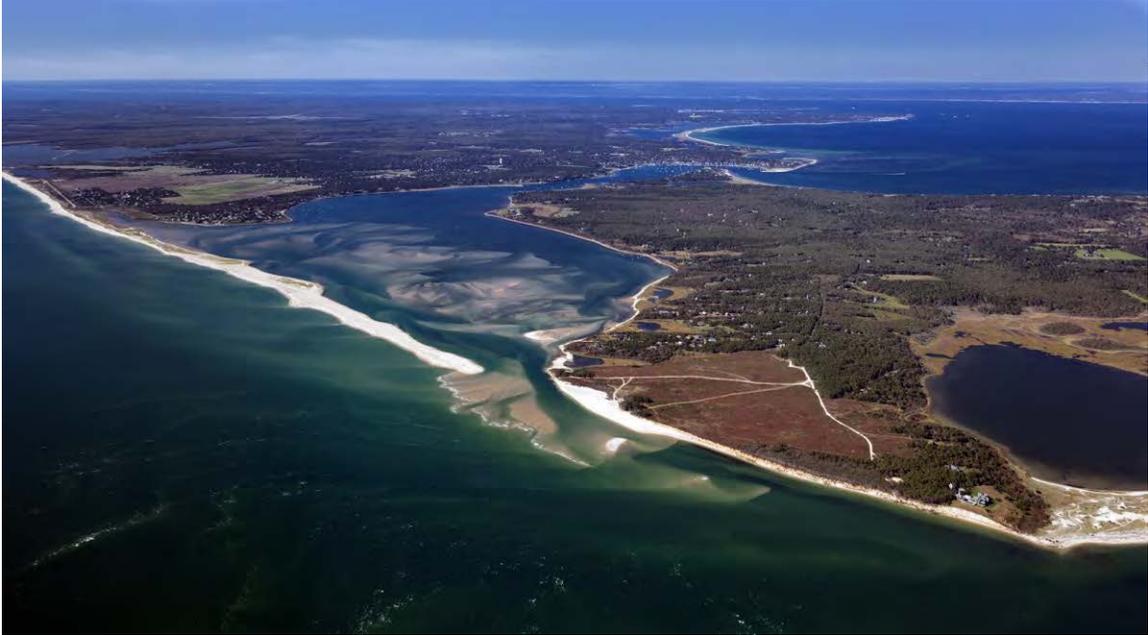
Figure 1A. Norton Point Inlet Oct 13, 2012 (source: Sterling Wall)
Looking Northwest showing Katama Bay, Katama Beach, and Wasque

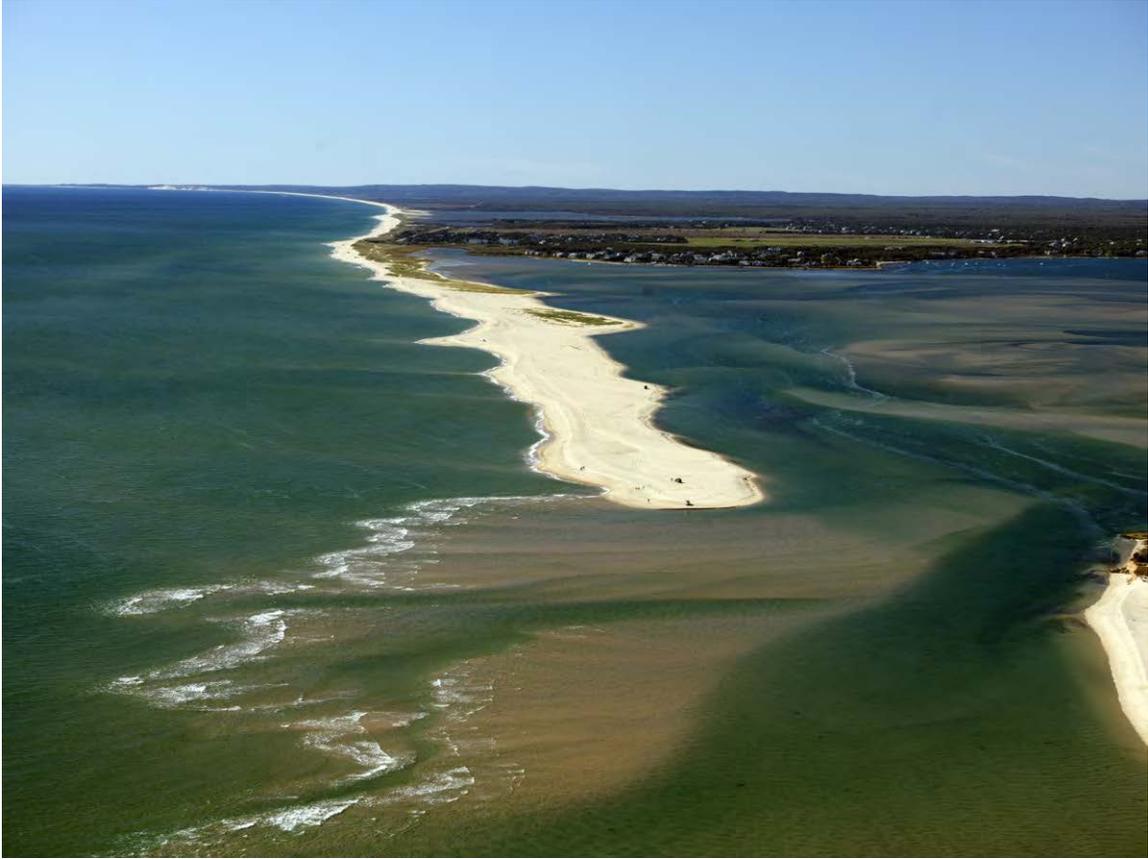
Figure 1B. Norton Point Inlet Oct 13, 2012 (source: Sterling Wall)
Looking West showing inlet, channel margin linear bar and Katama Beach.

Southern Katama Bay is dominated by sandy intertidal shoals (flood tidal deltas), which are relict from the past generations of tidal inlets on the barrier. However, the present main ebb tidal channel is diverted to a west-east orientation along the inside of the barrier beach. The tidal inlet at the west end of the Bay, adjacent to Chappaquiddick, is also west-east oriented. This deep tidal channel at the inlet is enclosed on the seaward side by an elongated sand bar extending east from Norton Point. This sand bar is being built from the sand moving east along the south shore. This bar plays multiple roles. It will be the platform that the Katama Barrier extends onto as it continues to migrate east. In its present form, it is also a *channel margin linear bar* that contains the inlet flow and holds it against the shore of Chappaquiddick. From the form of the bar, it appears that the flood flow has broken across it in the recent past (a shorter, more efficient route for the ebb flow), but the linear bar remains intact. About 1,500 feet east of the end of Katama Bay, sand from the ebb tidal channel, possibly derived from linear bar, formed an intertidal bar roughly in the middle of the channel which diverts ebb flow into two channels around it. This may cause higher velocities in these smaller channels and does hold part of the ebb flow adjacent the shoreline.

East of the ebb channel intertidal bar, the channel margin linear bar extends about 1,000 feet further east, continuing to hold tidal flow against the shoreline. Beyond this position, the air photo indicates that the deeper ebb channel continues along the shore to the east end of the island, including along the Schifter property. A less distinct linear bar is seaward of this channel.

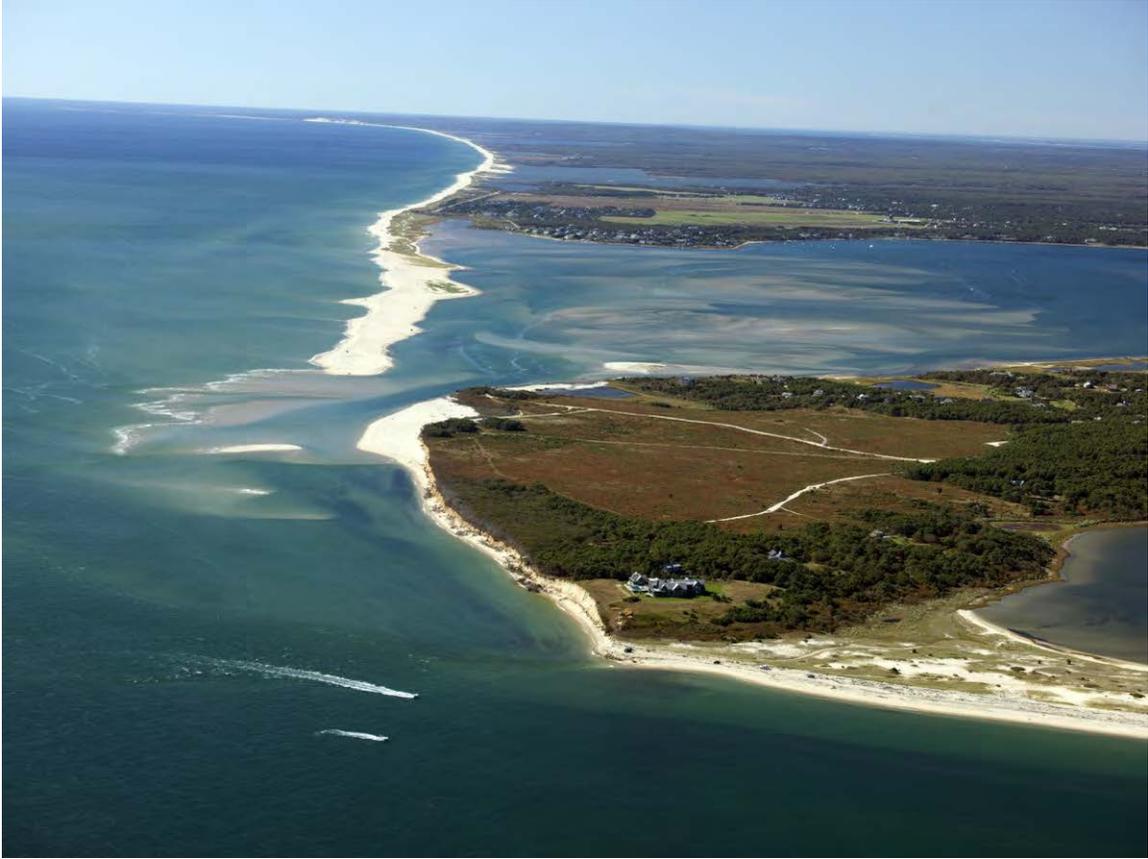
Figure 1C. Norton Point Inlet Oct 13, 2012 (source: Sterling Wall)
Looking West showing Schifter property, TTOR property, inlet and Katama Beach

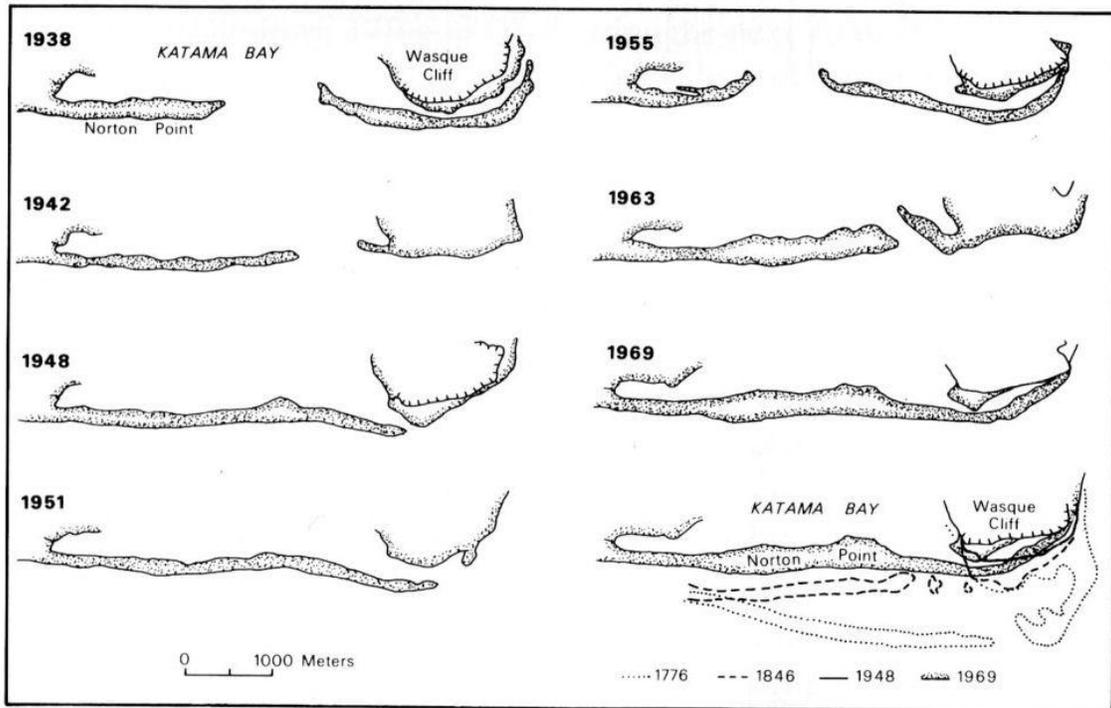
Figure 2. Shoreline changes along Katama Beach 1776 – 1969. (Source: Ogden, J.G., 1974, Shoreline Changes Along the Southeastern Coast of Marthas Vineyard, Massachusetts for the Past 200 Years, *Quaternary Research* v. 4, p. 496-508. Figure compiled in FitzGerald, D. M., 1993. Origin and Stability of Tidal Inlets in Massachusetts, p. 1 – 64, in Aubrey, D. G. and Giese, G. S. (eds), *Formation and Evolution of Multiple Tidal Inlets*)

The present form of the inlet draws strong parallels with the history of Katama Inlets compiled by Ogden (1974) and with the form of the Wasque shoreline from 1991 through 2010.

The Katama Barrier has extended in front of the Wasque region many times. The barrier overlapped the main shoreline diverting the inlet east, comparable to the present form, in 1948 and 1951. The ebb tidal inlet flowed inside this barrier along the all of the Wasque shoreline, in 1776, 1938, 1955, and 1969. Ogden's data suggested an average duration for the tidal inlet to be about 15 years.

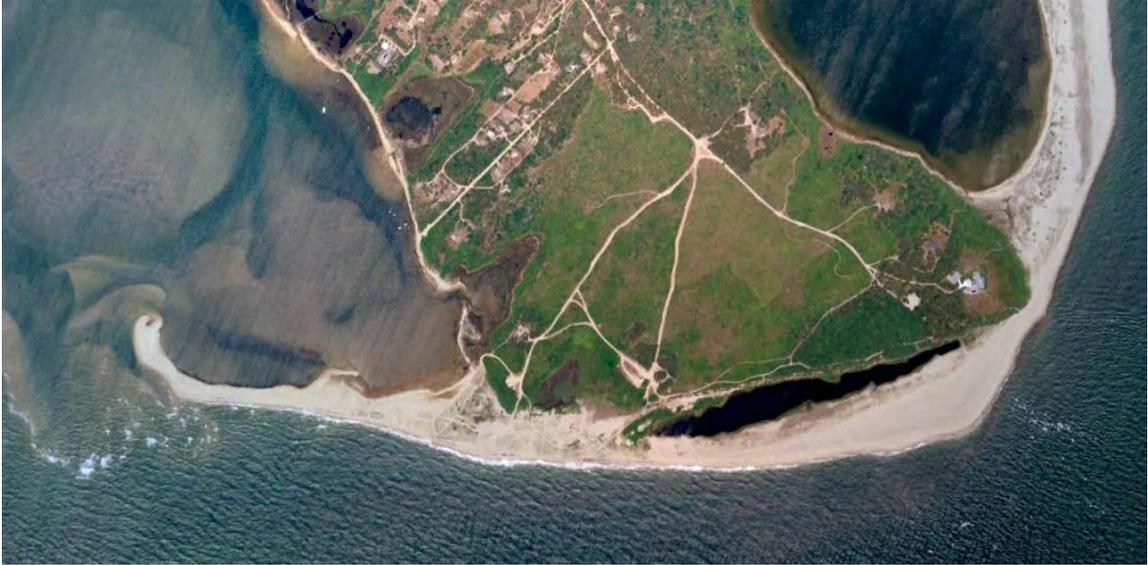
Figure 3. July, 2008 air photo showing protective beach along Wasque and the Swan Pond, which is a relict of an ebb channel from an earlier tidal inlet. (Source: Google Earth)

Air photos from 1991 through 2010 (Google Earth) show that a broad sandy beach fronted the glacial sands along the south shore of Wasque for this period. However, a long (2,300 ± ft), narrow (100 – 150 ft), deep (reportedly 8 ft), pond extended between the barrier and the glacial island. This pond was referred to a “The Swan Pond.” This unusual pond was likely the relict ebb channel similar to present inlet conditions, and may have formed around 1969, based on Ogden’s maps.
